Title: The Mechanism of Corrosion of Aluminium Zirconium Silicate (AZS) Material in the Float Glass Furnace Regenerator

Authors: S.M. George, P.W. Haycock, R.M. Ormerod

To appear in: *Journal of the European Ceramic Society*

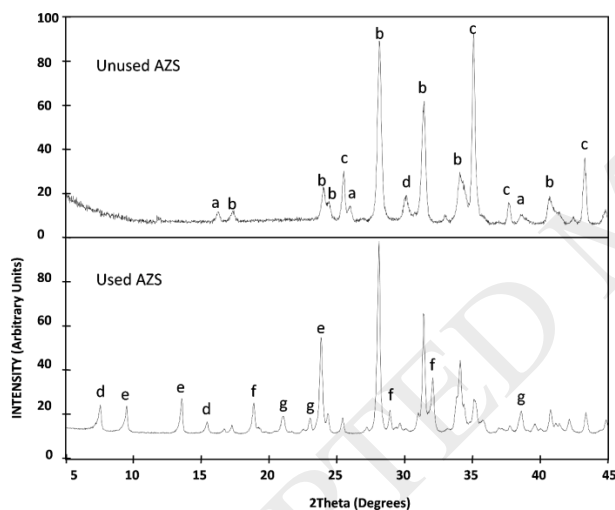
Examination using XRD showed that monoclinic zirconia (baddeleyite), tetragonal zirconia and alpha alumina (corundum) are the main components of the virgin material (Table 2). XRD also confirmed chemical changes caused during service. The identification of corrosion products was confirmed using IR spectra (Figure 3 and Table 3).

Figure 3. XRD of Unused and used material (F2) showing the peak positions of: a) mullite; b) monoclinic zirconia; c) alpha alumina; d) beta' alumina; e) sodalite; f) sodium sulphate; and, g) nepheline

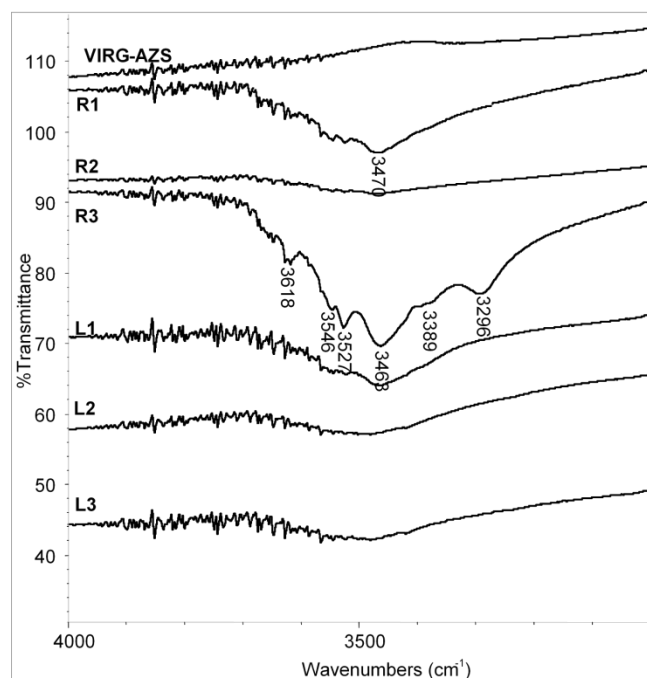
An absorption band consistent with the OH group stretching mode in Al(OH)₃, is present in R3 (Figure 5.), occurring between 3618 cm⁻¹ and 3296 cm⁻¹ resolved into six separate signals [26]. This is indicative of OH groups in gibbsite being situated within the layers of the crystal and forming hydrogen bonded bridges between the layers. The absorption bands at 3463 cm⁻¹, 3389 cm⁻¹ and 3296 cm⁻¹ in the IR spectrum of R3 correspond to OH bonds between adjacent layers and the bands at 3618 cm⁻¹, 3546 cm⁻¹ and 3527 cm⁻¹ correspond to the vibrations of longer hydrogen bonded OH groups within the layers.

Figure 5. The IR spectra of used AZS from F1 showing the absorption bands of gibbsite in R3

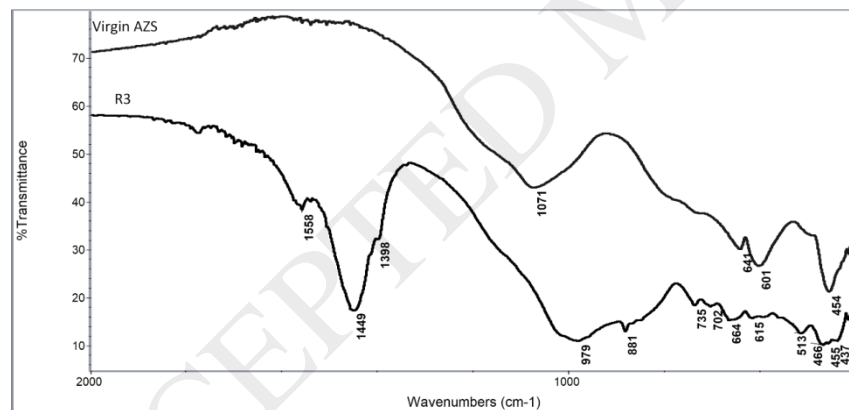
In R3 (Figure 6.) bands at 1558 cm^{-1} , 1449 cm^{-1} , 1398 cm^{-1} , 881 cm^{-1} and the complex area between 735 and 615 cm^{-1} correspond to the presence of the carbonate, Na_2CO_3 [18].

Figure 6. IR Spectra of unused AZS and R3 Microstructure

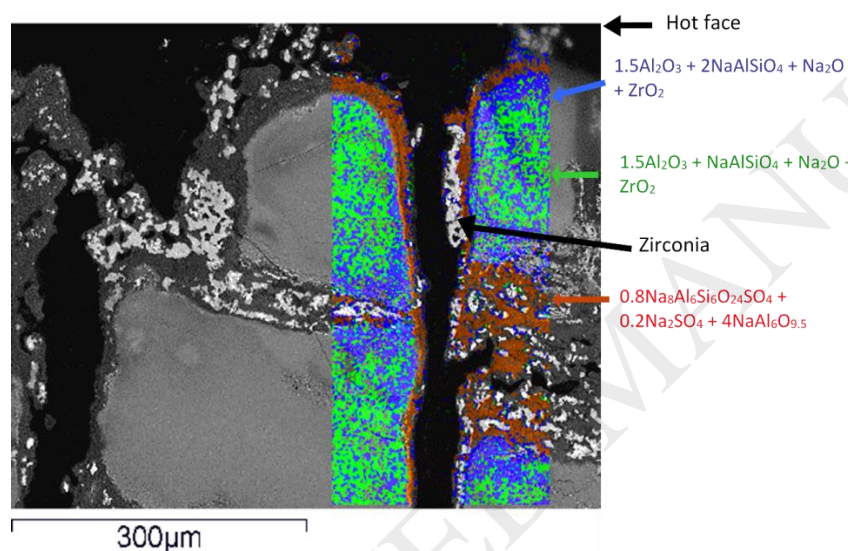
Sodium aluminium oxide ($\text{NaAl}_6\text{O}_{9.5}$) is formed at the refractory surface with distinct areas. At 3 mm away from the hot face there is a region containing sodium, one containing both sodium and sulphur, and one resembling the original refractory containing no sulphur and a negligible amount of sodium. The distribution of the compounds in Table 6 is shown in Figure 9 and Figure 10.

Figure 9. Colour-enhanced EDA map of the surface of used AZS, L3

The integrity of the surface is no longer intact as large channels are evident between the main parts of the material, giving the material a “finger-like” like appearance. The outer surfaces of the channels and cracks are coated in a film containing nosean and sodium sulphate and sodium aluminium oxide. This substance is devoid of aluminium silicate and dispersed zirconia. Zirconia has been deposited as large, recrystallised grains evident in the enlarged porosity.

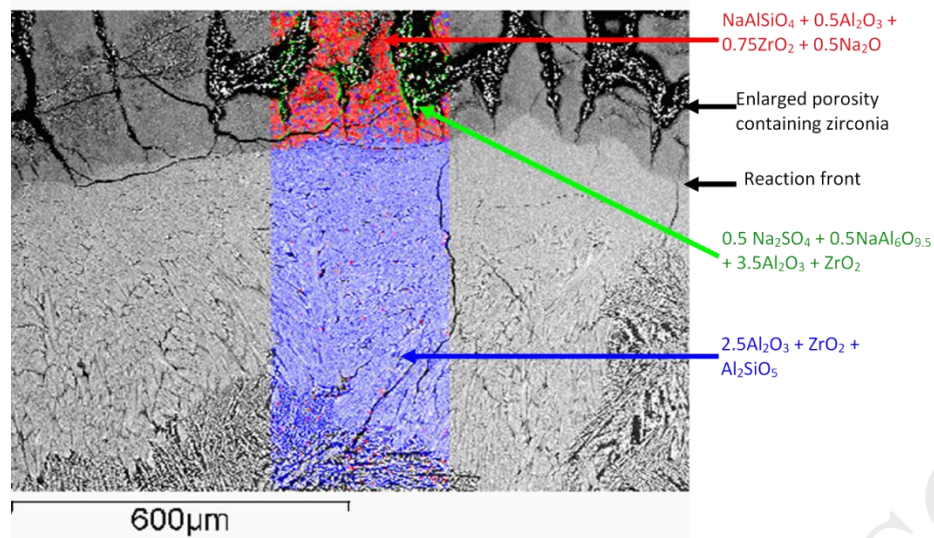
At 3 mm into the material from the surface, sodium sulphate can be seen lining the pores (Figure 10). Whereas sulphur has remained at the surface of the material, either on the hot face of the block or lining the pores, sodium has penetrated into the bulk of the material where it has reacted with alumina and aluminium silicate to form sodium aluminium oxide at the interface and sodium aluminium silicate. A front can be seen to which sodium penetration has “soaked”.

Figure 10. EDA map of used AZS (L3) 3 mm from the hot face

The sodium-containing region in the EDA map of L3, 3 mm featured increased microcracking. It is not clear whether the cracking was caused by the loss of the glassy phase and volume increase associated with the formation of sodium aluminium silicate, nosean and sodium aluminium oxide and subsequent temperature cycling, or whether the cracking occurred after service, as the piece cooled down.

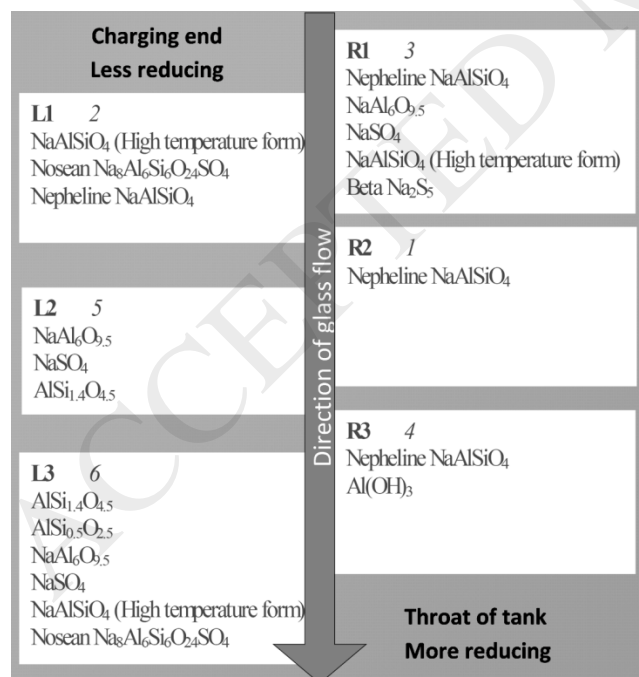
The types of corrosion products formed on the left and right sides of the float glass furnace, F1, indicate that the conditions in the regenerators on the right side were more reducing than those on the left. A diagram showing the distribution of compounds across the furnace highlights this fact (Figure 11). It can be seen that where the conditions are more reducing, fewer corrosion products are formed and the severity of corrosion is less.

Figure 11. Diagram to show the distribution of corrosion products formed during service in F1 where the number in italics indicates the degree of resistance to corrosion (1>6)
