Title: The Mechanism of Corrosion of Aluminium Zirconium Silicate (AZS) Material in the Float Glass Furnace Regenerator

Authors: S.M. George, P.W. Haycock, R.M. Ormerod

To appear in: *Journal of the European Ceramic Society*

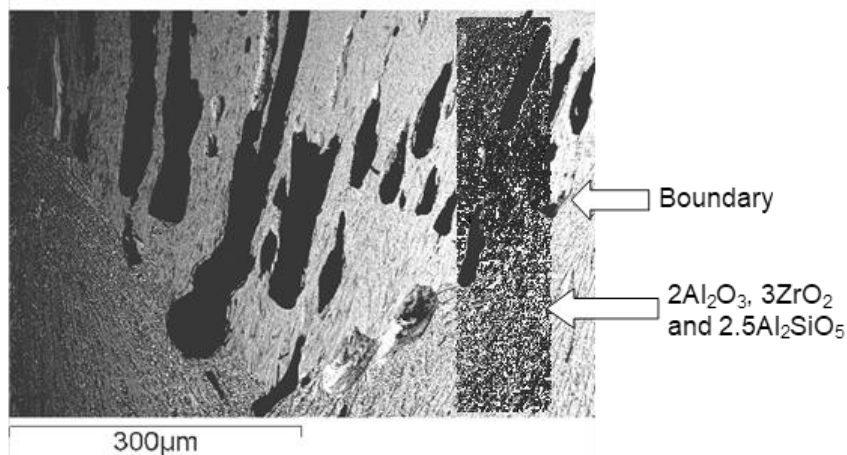
At a depth of 3 mm from the hot face (Figure 8) Tubular pores originate and radiate towards the surface of the material from a definite boundary. Beyond this boundary, there is a dense, homogenous inner structure and no tubular pores.

Figure 8. SEM image of unused AZS material 3 mm from the hot face with shaded area showing region analysed by EDA
